**GWYNEDD COUNCIL**  
Cyfadran Adnoddau/Resources Directorate  
Gweinyddol a Gwarchod y Cyhoedd/Administration and Public Protection  
Adain Iechyd Yr Amgylchedd/ Environmental Health Section  
Uned Llygredd/ Pollution Unit

**REMEDIATION NOTICE**

**10 & 12 Stryd Bangor/Bangor Street Y Felinheli, LL56 4JD**  
**Contaminated Land Outlined in red**

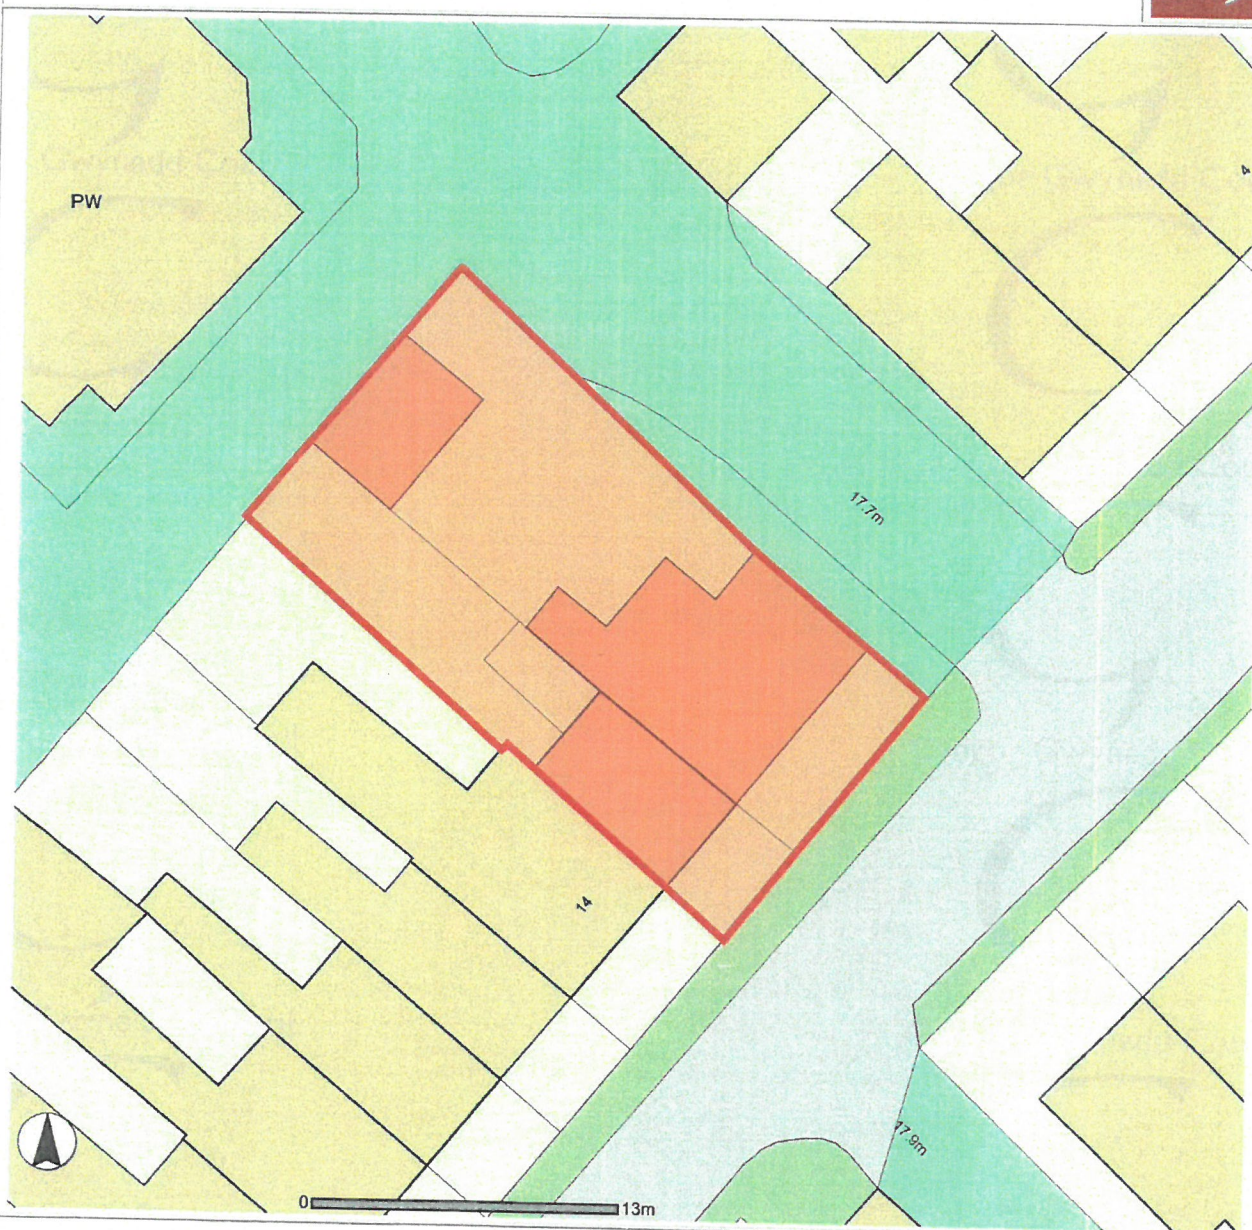
- Number 10, Bangor Street, Y Felinheli, Gwynedd, LL56 4JD  
and
- Number 12, Bangor Street, Y Felinheli, Gwynedd, LL56 4JD.

Scale - 1 : 300  
 NGR - SH 52580 67705

The location and extent of the contaminated land to which this Notice relates is set out in **Schedule 1**.

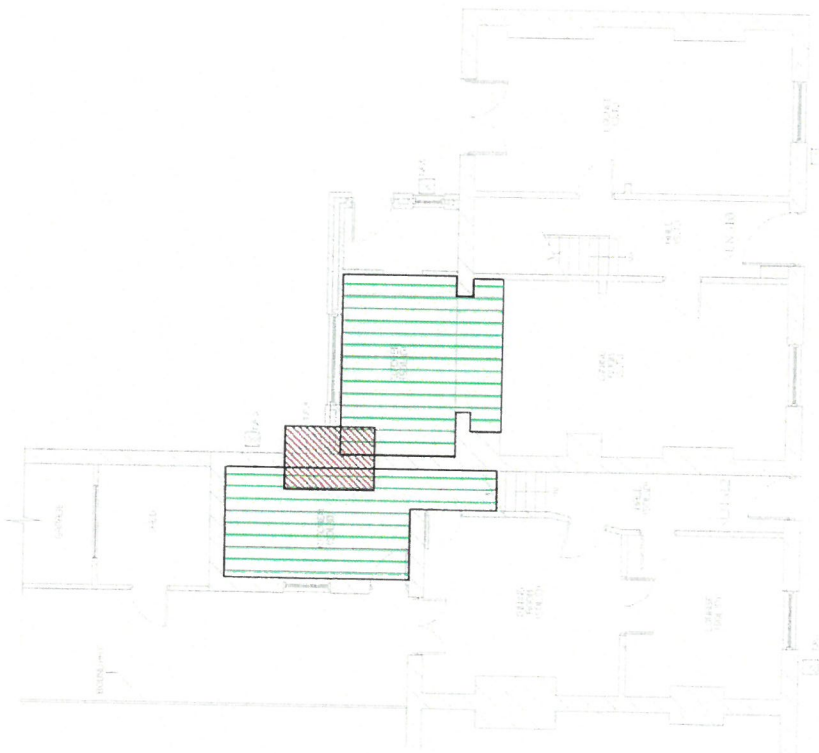
Area where removal/treatment/ gas protection required (subject to confirmation following breaking out and removal of floors)
